# TIMBERWISE

## Case Study: Pizza Hut, Peterborough

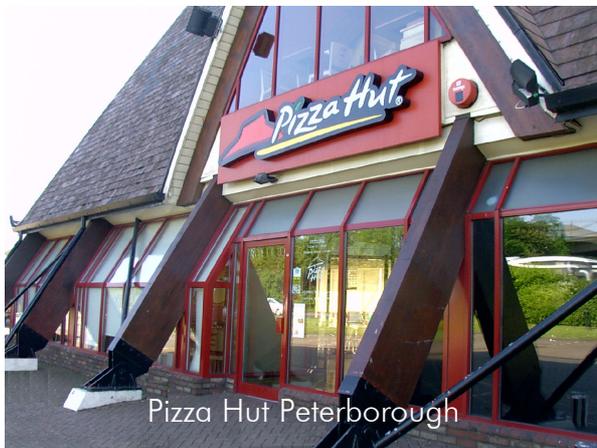
Pizza Hut Peterborough

The unusual construction of the building has its roots in North American design with 6 huge timber 'A' frames providing the main structure for the building. The timbers which measure are 650mm x 180mm are made from 14 sections of soft wood laminated together to form the large sections of timber.

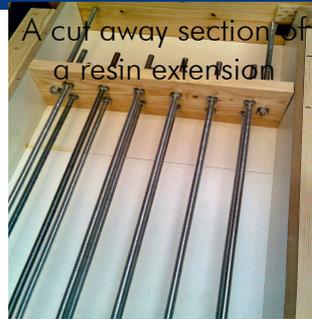
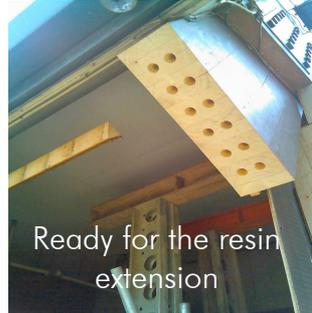
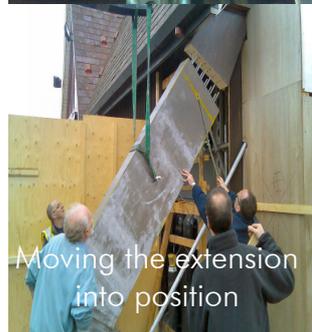
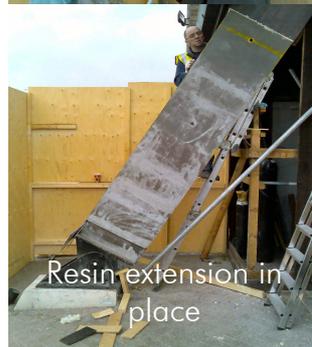
In recent years Wet Rot decay had been found in several of the exposed beam ends which are exposed to the elements of the British weather. At the time seven of the twelve exposed beam ends had been repaired by a local contractor but sadly the Wet Rot had returned.

The brief from Pizza Hut was simple: Remove the risk of further fungal decay attacking beams forever. The solution that Timberwise proposed was to form a new solid resin extension that would use steel bars and resin to form the bond between the existing wood and the extension.

The legs were cut back in a difficult and time consuming operation to allow the solid resin extensions to be fixed in to position. Despite the removal and refixing of the glazed frontage the outlet continued trading with minimum disturbance..

The end result is that the building benefits from having sympathetically restored timbers to the exterior and that the new resin engineered struts will ensure that the 'A' frames will be kept decay free and in good condition for years to come.
